**INVESTIGATION AND REVIEW**

**THE TAURANGA CITY COUNCIL'S INVOLVEMENT**

**WITH 21 PROPERTIES IN THE BELLA VISTA SUBDIVISION**

**REPORT OF HON PAUL HEATH QC**

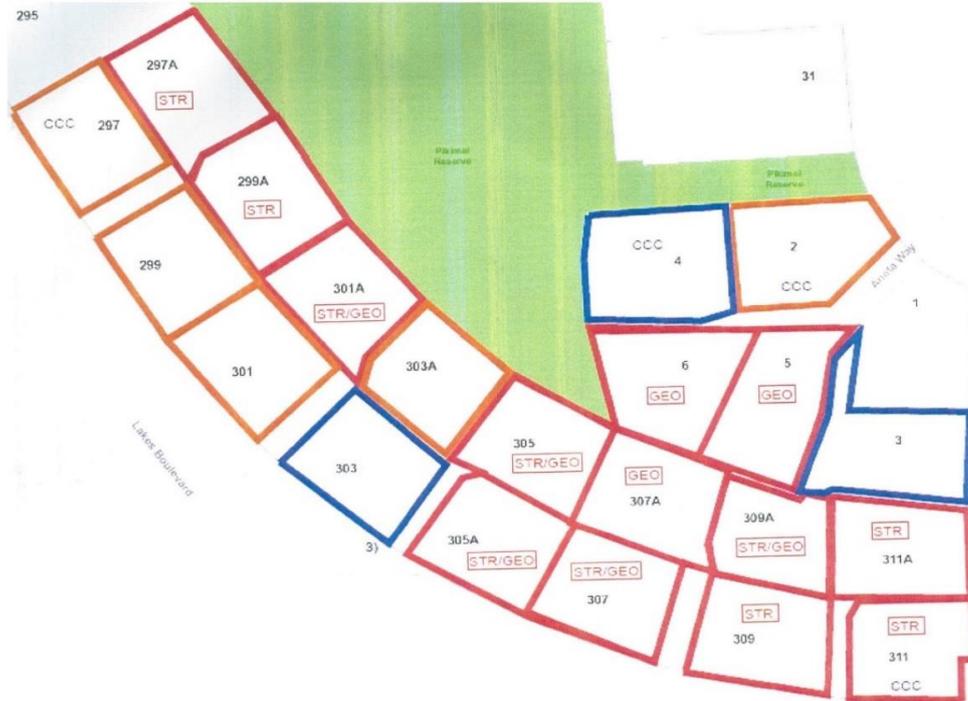
[132] To explain some of the annotations on the diagram:

- (a) The letters “CCC” on numbers 297 and 311 Lakes Boulevard and 2 and 4 Aneta Way represent those properties for which code compliance certificates were issued.
- (b) The properties that are marked “STR” are those which were declared dangerous for structural reasons only.
- (c) The properties that are marked “GEO” are those which were declared dangerous on geotechnical grounds alone.
- (d) The properties that are marked “STR/GEO” are those which were declared dangerous for both structural and geotechnical reasons.

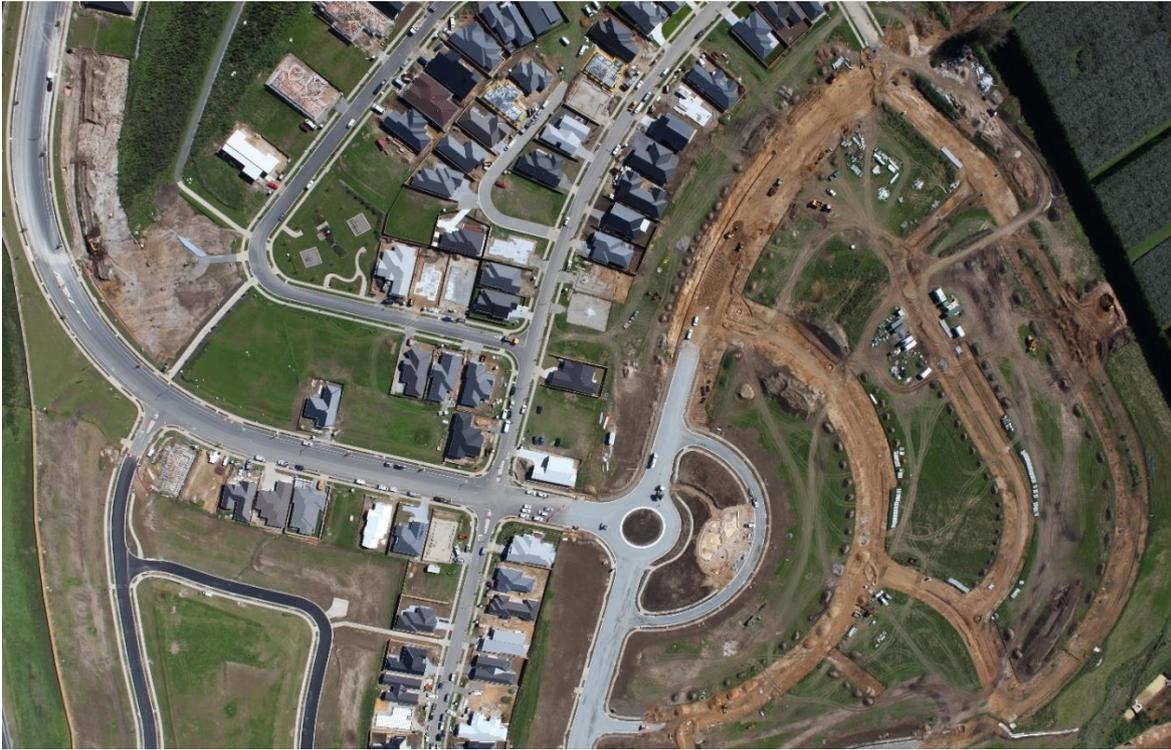
(a) 6 April 2016

- (a) The absence of any significant earthworks on the properties as at 6 April 2016.
- (b) Building platforms were being created, as at 9 August 2016, at three of the Aneta Way sites and 311 Lakes Boulevard. Machinery can also be seen at 309 Lakes Boulevard<sup>116</sup> as at 9 August 2016.
- (c) The partial erection of two dwellings, and other building works, as at 22 November 2016.

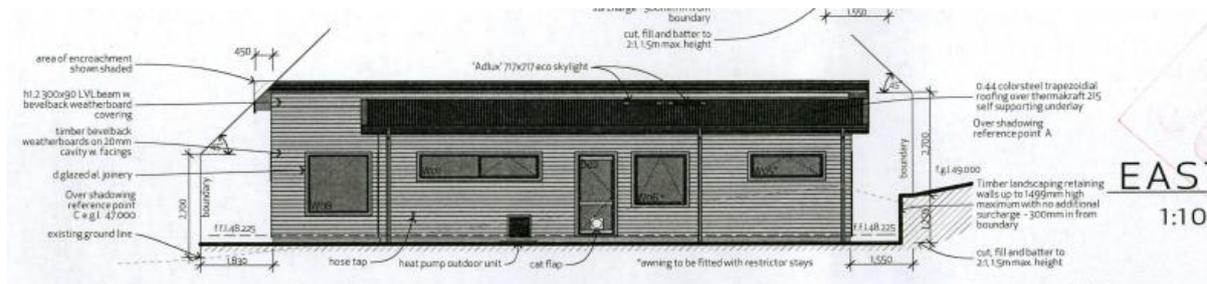
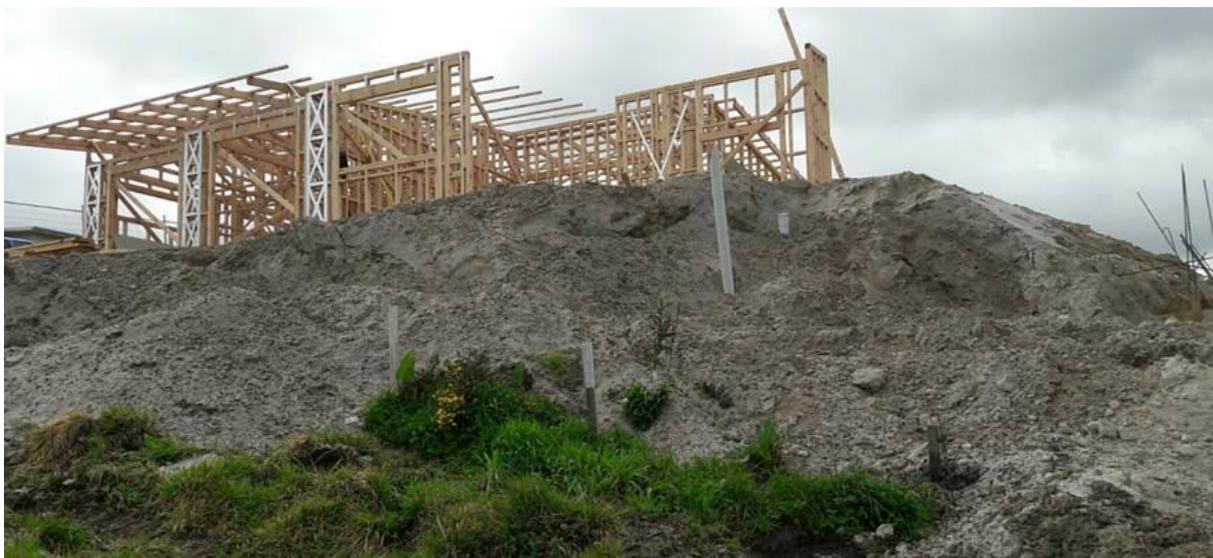
[179] I have been provided with a copy of the approved plans for 4 Aneta Way, that show the east elevation. This drawing, taken from the original building consent application, shows limited fill being required on the left-hand side. I compare that drawing with photographic evidence that depicts the extent of the earthworks around the time of the 26 August 2016 meeting. The drawing and the photograph are set out below:
