**INVESTIGATION AND REVIEW**

**THE TAURANGA CITY COUNCIL'S INVOLVEMENT**

**WITH 21 PROPERTIES IN THE BELLA VISTA SUBDIVISION**

**REPORT OF HON PAUL HEATH QC**

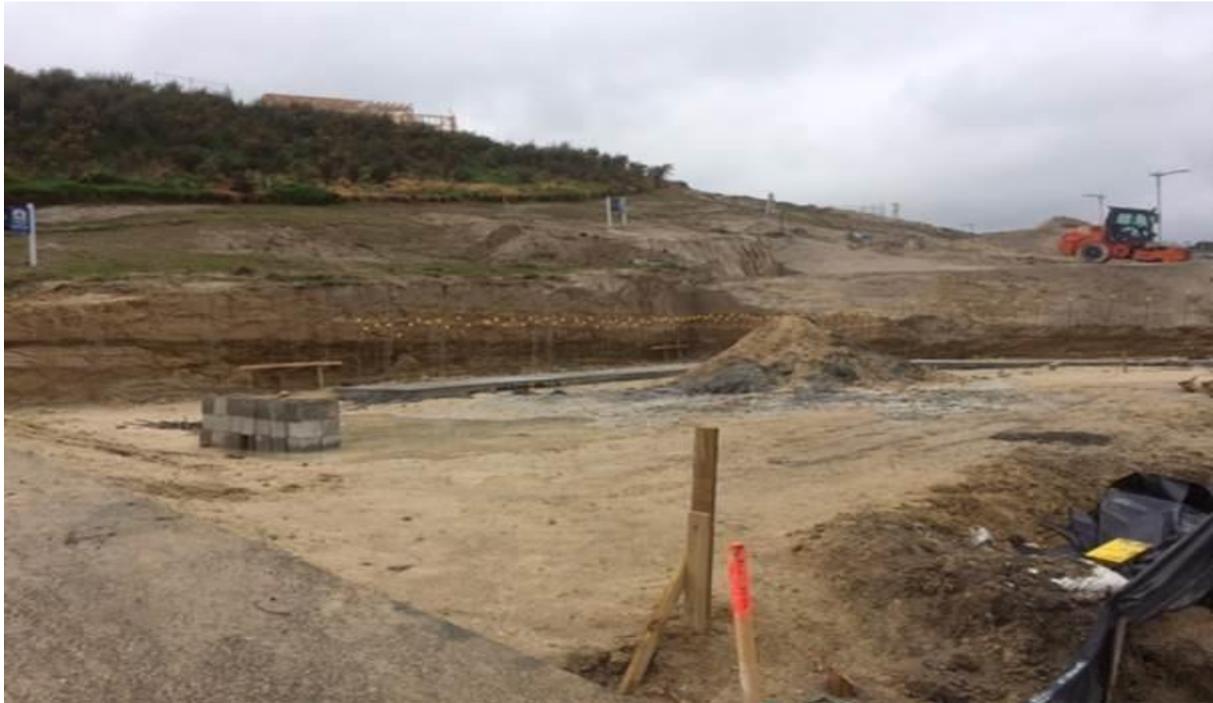
[159] In addition, the Council has provided to me some aerial photographs that depict the extent of earthworks undertaken during 2016. Because Tauranga City is expanding rapidly, aerial photographs are taken regularly to ensure geographical information systems are robust for both internal and external purposes. I refer to three photographs, taken on 6 April, 9 August and 22 November 2016. The photographs taken on 6 April and 22 November depict the construction site at the top left-hand side. The 9 August photograph shows the site more directly. The public access-way running from Lakes Boulevard to Penetaka Heights can be seen in each photograph, as can the new Aneta Way, running off Penetaka Heights. The locations can be better understood by reference to the diagram at para [131] above. Taken together with the June 2016 photograph that I have already reproduced,<sup>115</sup> they depict various stages of development of the subdivided lots. In date order, they show:
